Manhole Inspection Summary

Manhole # S27M__034MH

Insp Date: **5/7/08 2:34 PM**

Location Address: **876 Carrol St**

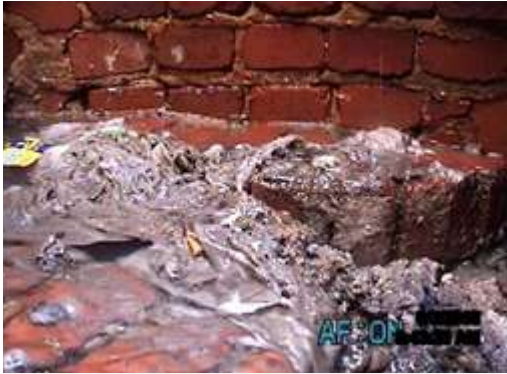
Defect 3

Condition: ☐ Sound ☐ Cracked ☐ Root Intrusion ☐ Deteriorated ☐ Leaks ☒ **Debris**

debris in channel

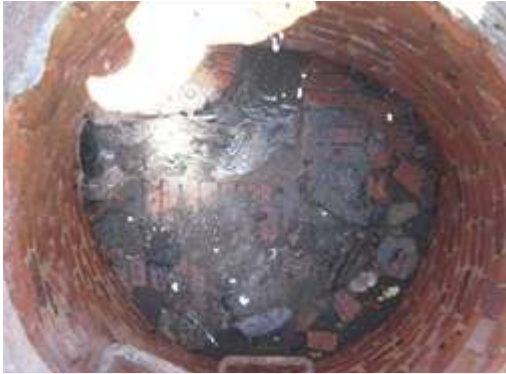
Defect 1

Steps Count: **3** Missing: **0** ☒ **Corroded**

Corroded Steps

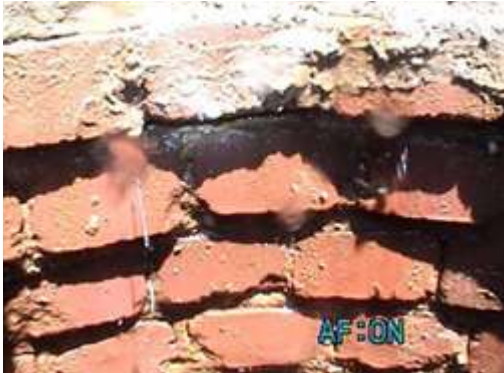
Defect 2

Condition: ☐ Sound ☐ Cracked ☐ Root Intrusion ☐ Loose Brick ☒ **Deteriorated**

Infiltration: ☐ None ☐ Joint ☐ Cracks ☒ **Mortar** ☐ Roots ☒ **Wall**

Infiltration: ☐ None ☐ Joint ☐ Cracks ☐ Mortar ☐ Roots ☒ **Wall**

chimney flow wall, corbel flow wall, mortar

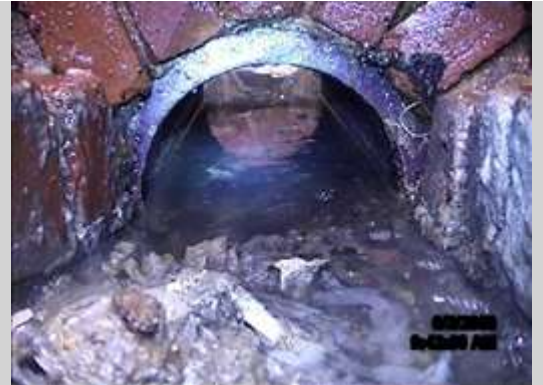
12 O'Clock Outflow

Reflection of another manhole

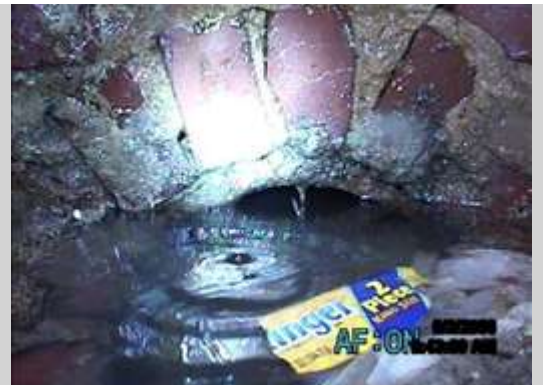
10 O'Clock Inflow

almost full of water and debris

Pipe Height: **8.4** (in.) Rod and Bar (Angled)
Pipe Material: **Clay** ☐ Pipe Lined
Invert Depth: **5.43** (ft.) Flow Characteristics: **Slow**
Deposits: ☐ None ☐ Mud ☐ Sludge ☒ **Debris** ☐ Grease
Silt Depth: **4** (in.) Deposits Extent: **Heavy**
Infiltration: **None** Pipe Seal Cond: **Sound**
